Baton Rouge Refinery Facility (BRRF)

CAA §112(r) CEI Photo Log

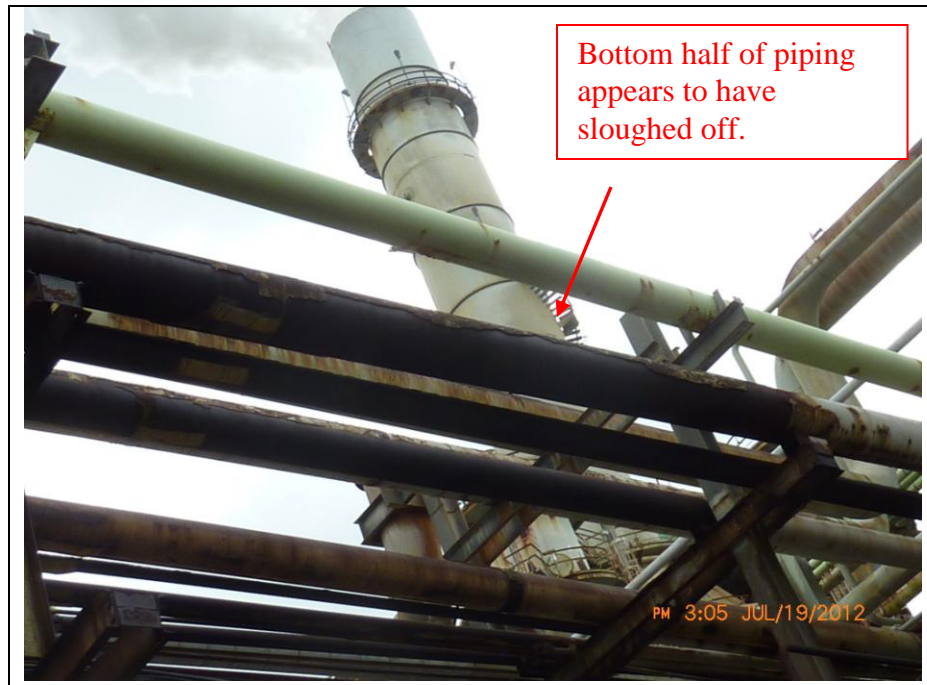
PHOTO #: 7

COMMENTS: Overhead piping located in HCLA unit block near D-115 shows signs of significant corrosion and scaling. A significant amount of metal has sloughed off from the bottom of the pipe that appears to be second from the top of the photograph. The unit operator was unable to determine the process fluid in the pipe but believed it to be high pressure hydrogen.

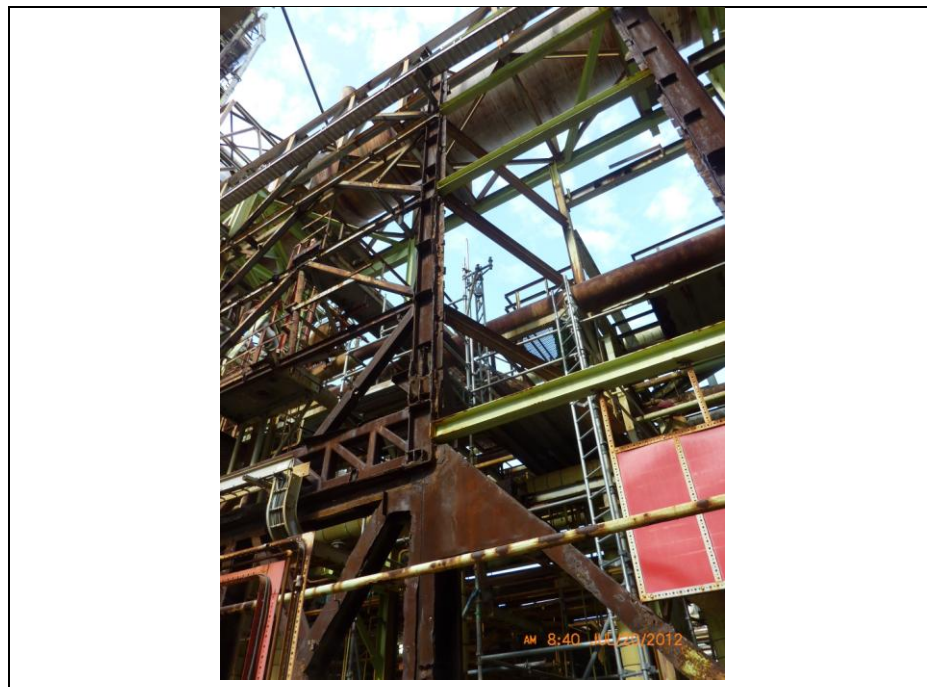
PHOTO #: 8

COMMENTS: Steel beams supporting the PCLA wet gas scrubber feed pipe shows signs of significant corrosion.
